Limited Visual Dam Safety Inspection Summary Report

MA-095

Haiku Reservoir

Limited Visual Dam Safety Inspection Conducted on: 05 April 2006

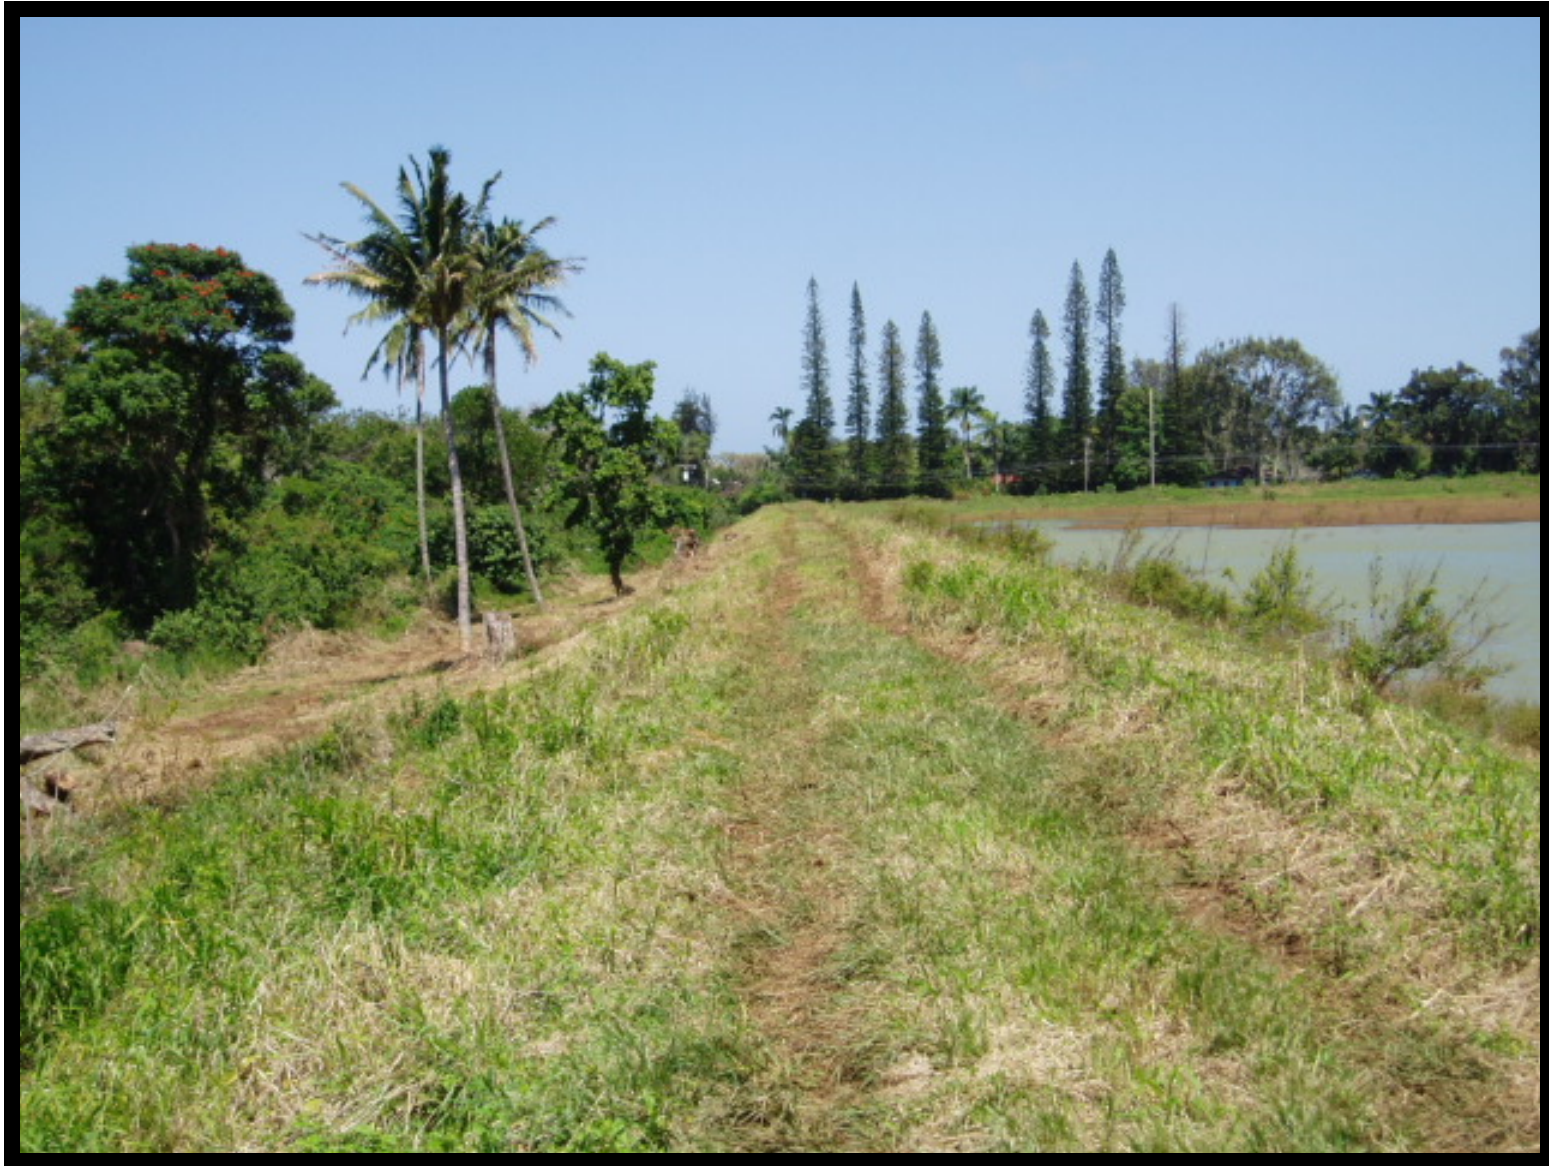
095 Crest and downstream slope. Vegetation management is excellent. Short grass covers the crest and slope.

- 1) Vegetation conditions on the embankment are excellent. Short grass covered the upstream slope, crest, and downstream slope of the dam. The dam owner should continue with the current vegetation management practice.
- 2) Remove brush growing along the downstream toe of the right half of the dam.
- 3) Routinely measure and monitor the flow out of the PVC toe drain outfall pipes located at the outlet works. Compare flowrates to reservoir pool elevations.

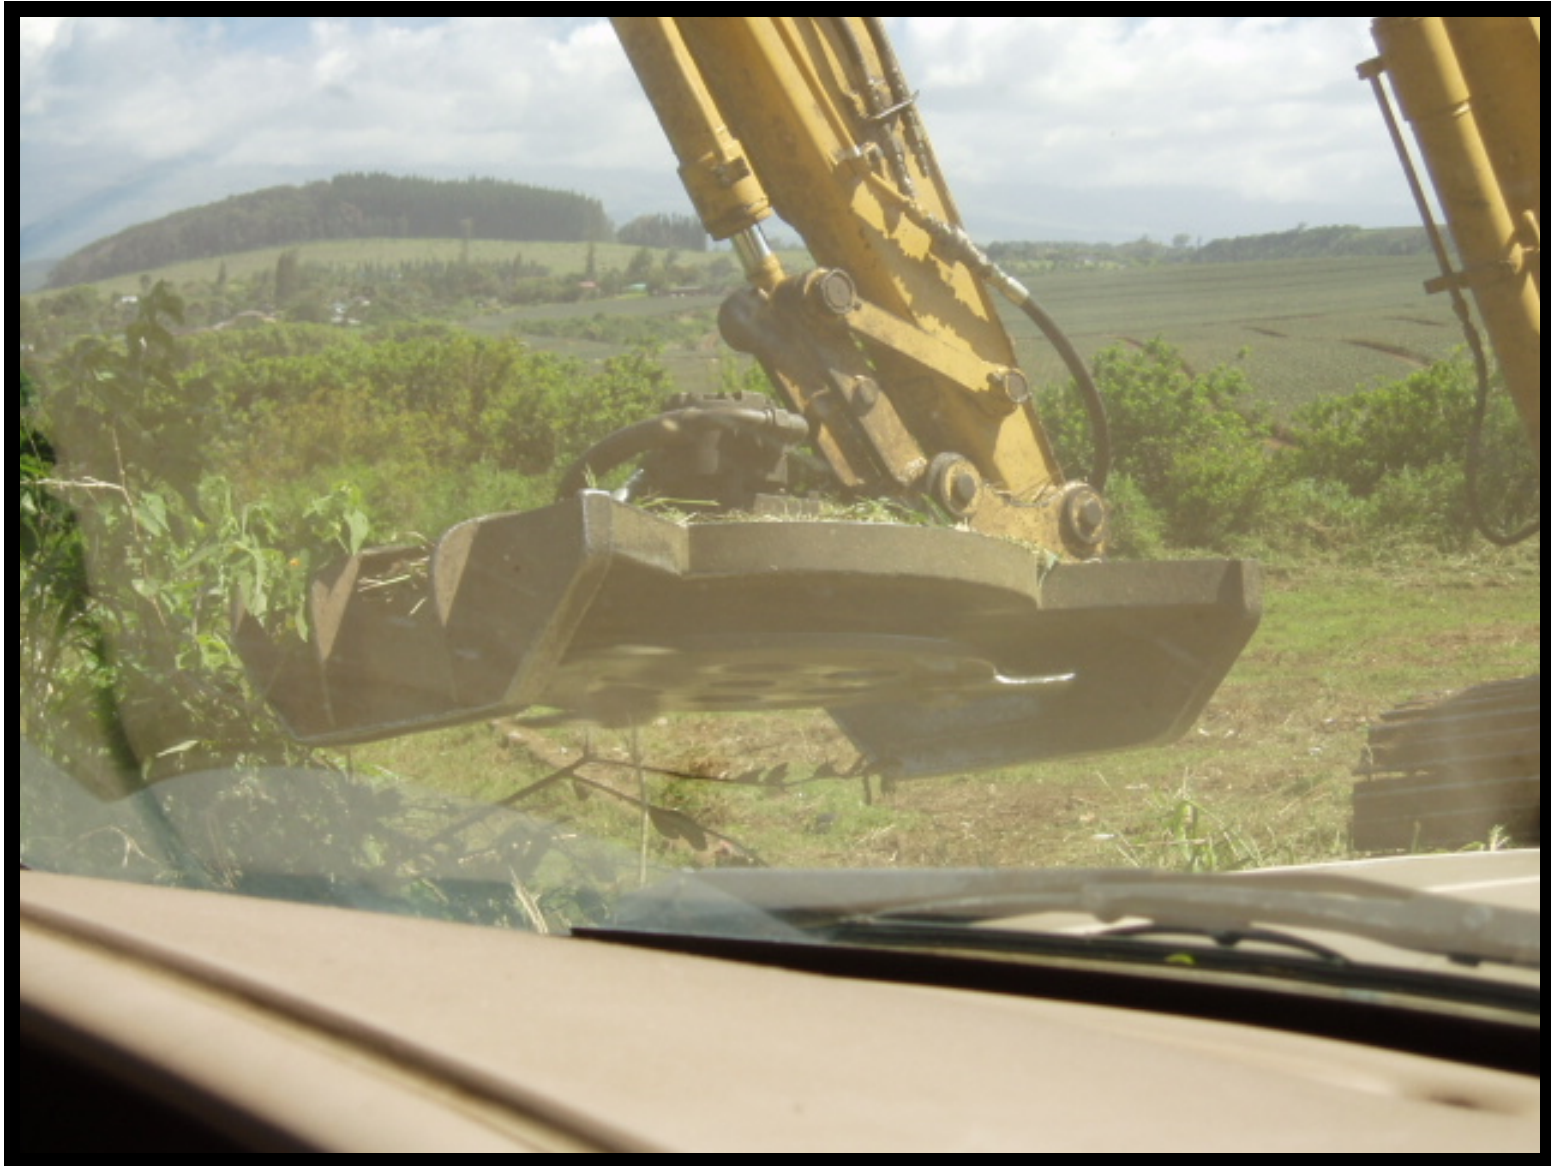
095 Cutter attachment on an excavator. The cutter attachment is used to cut brush.

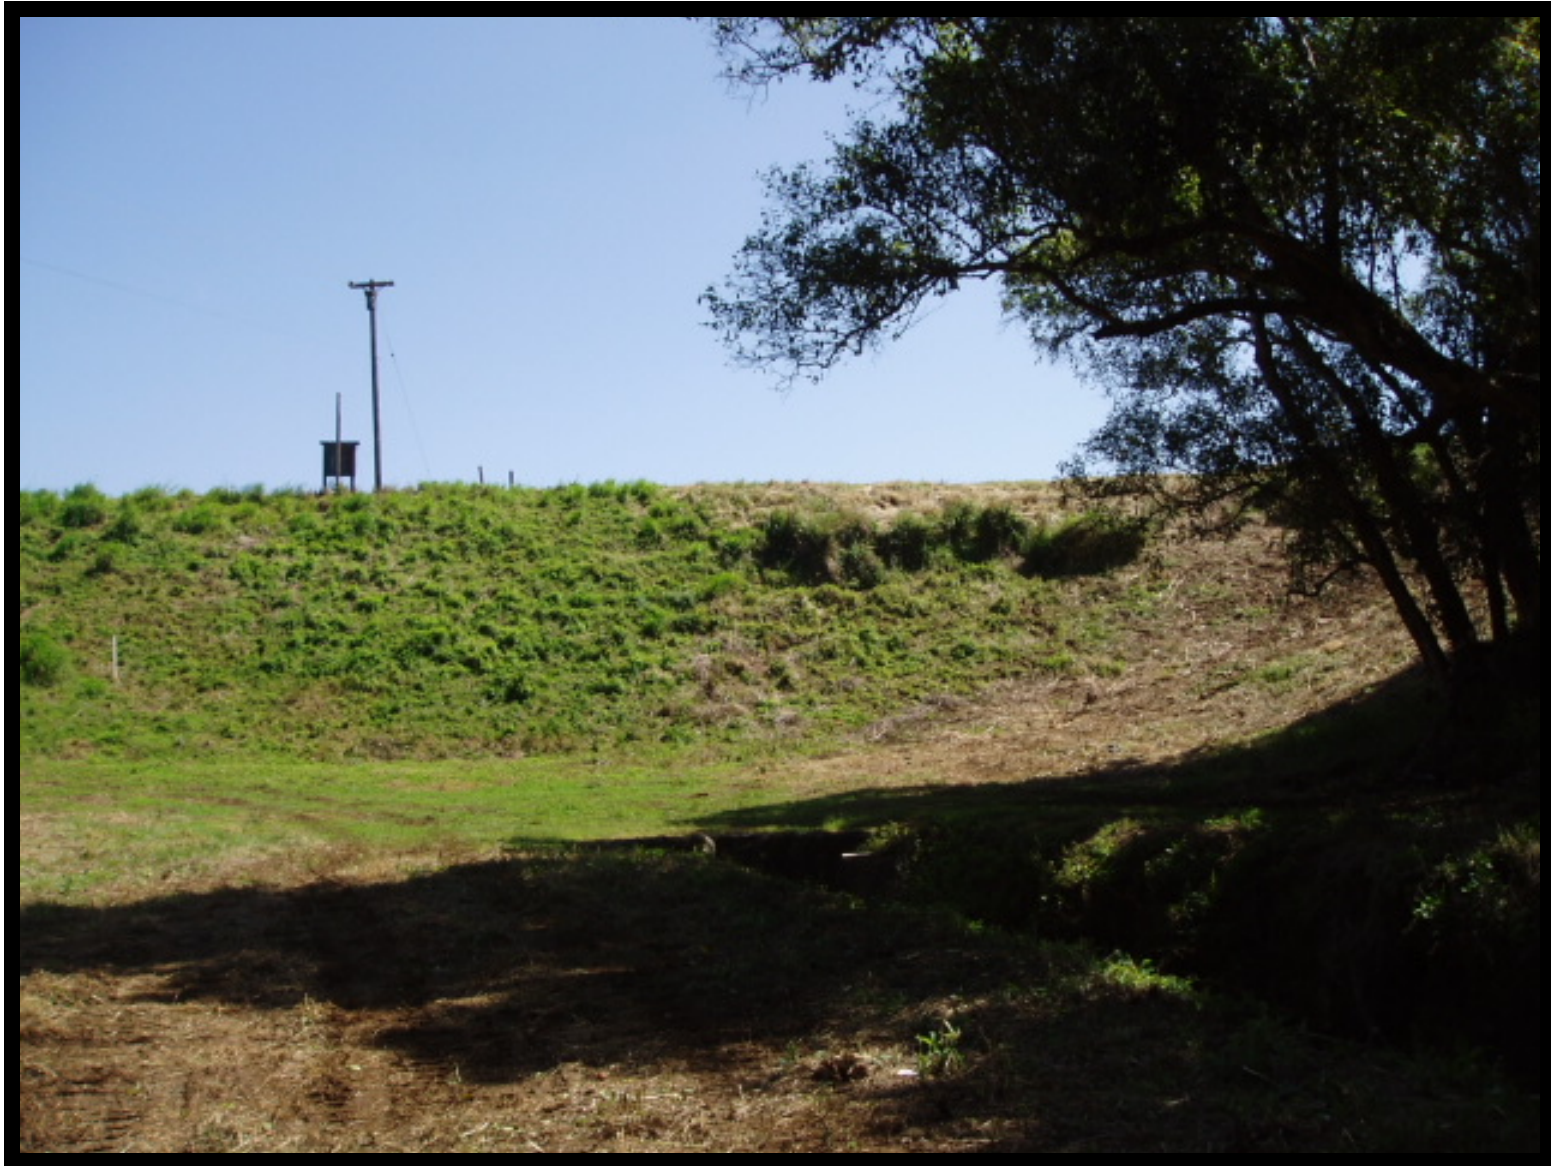
095 Downstream slope near the outlet works. Vegetation on the slope is excellent. The grass is short and does not hinder inspection. (panorama) 1

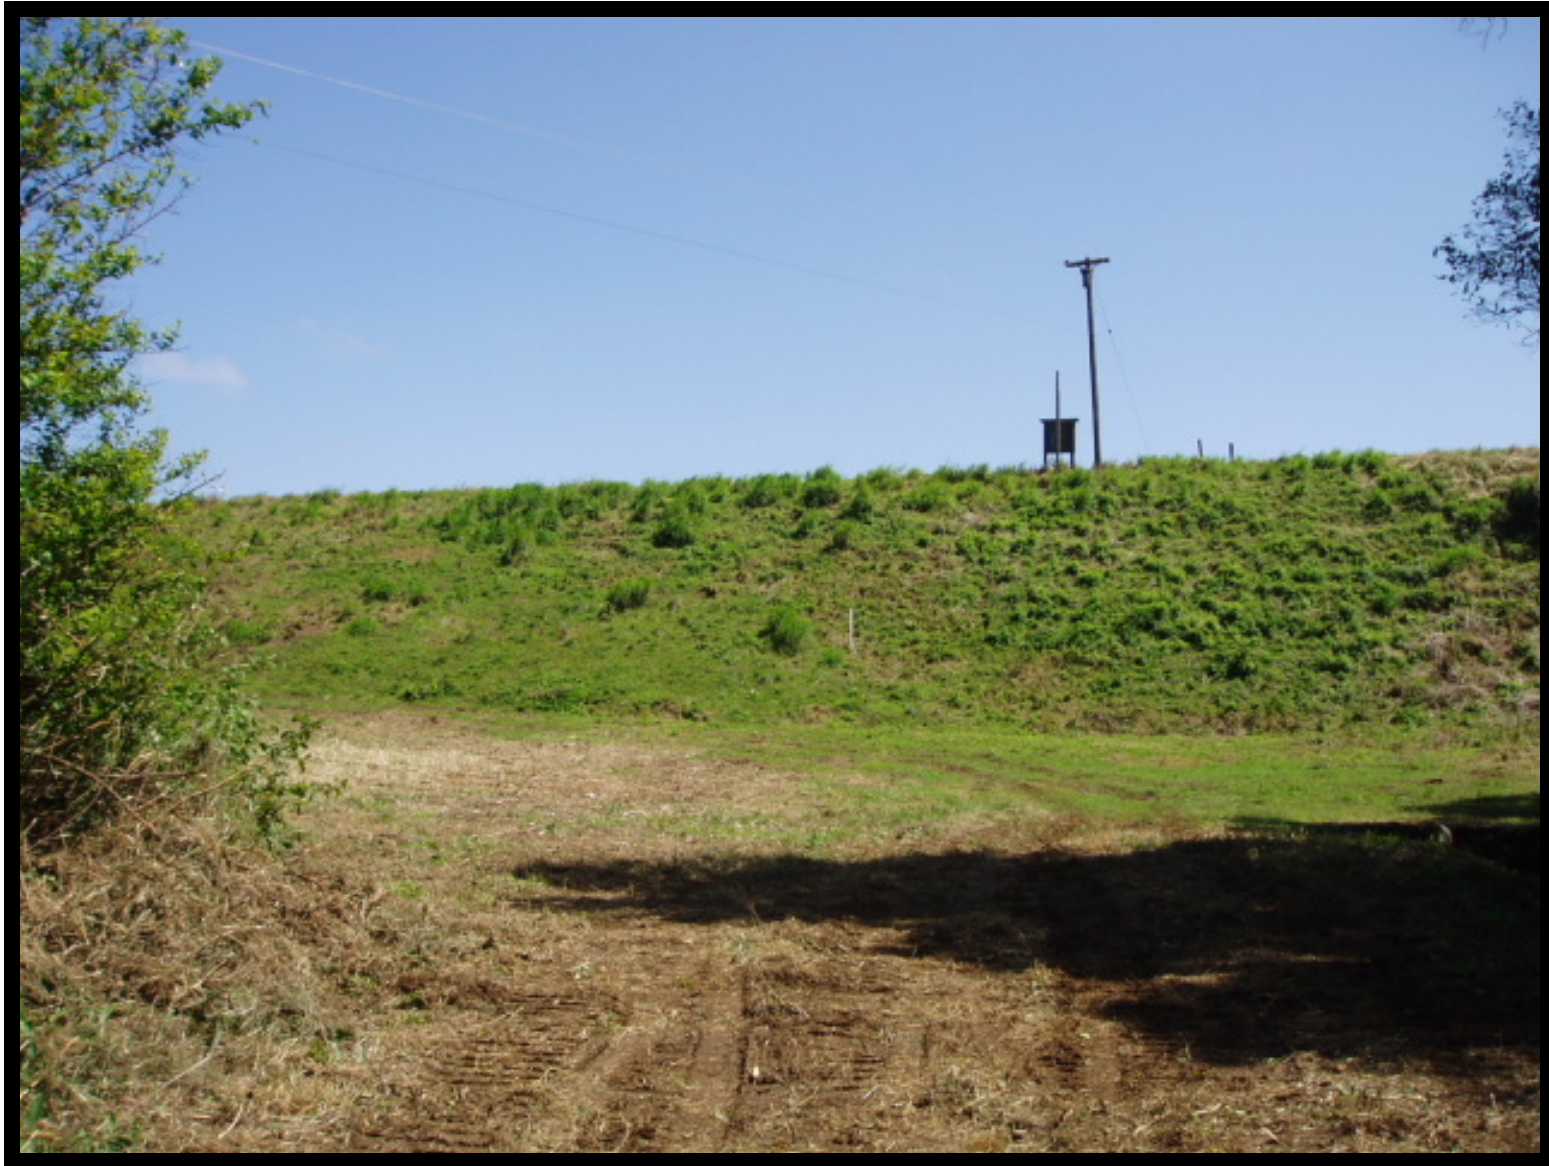
095 Downstream slope near the outlet works. Vegetation on the slope is excellent. The grass is short and does not hinder inspection. (panorama)

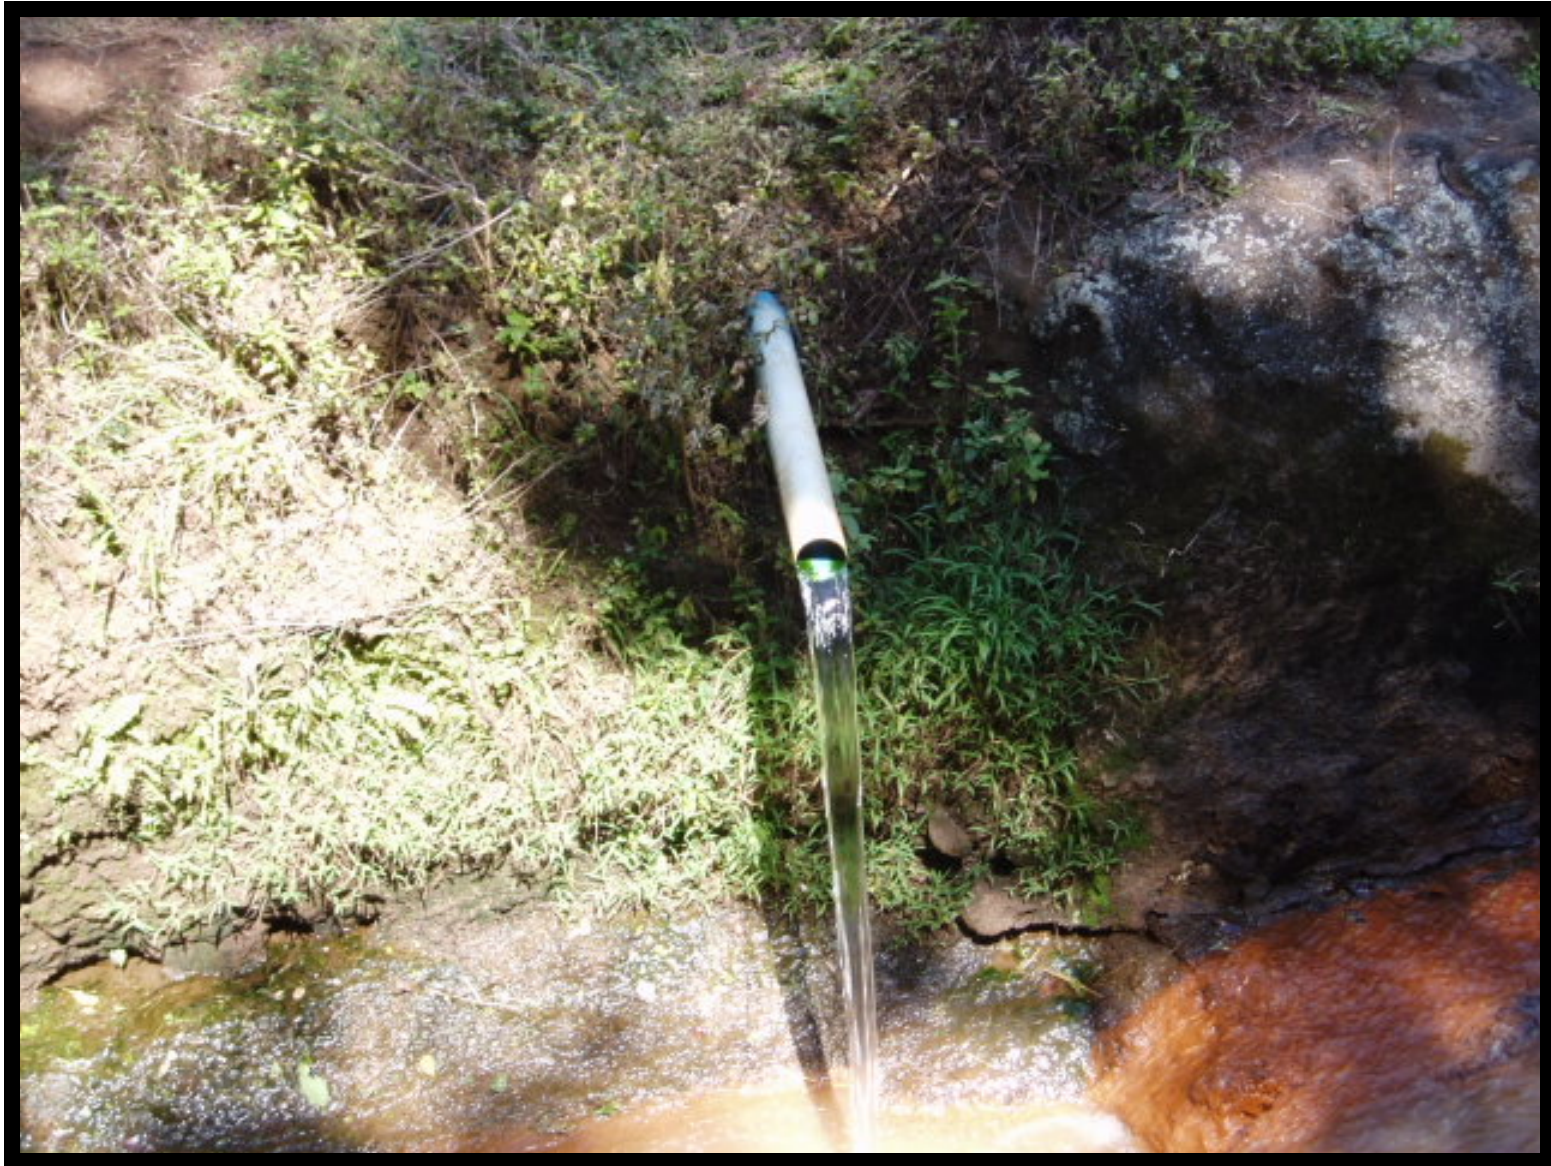
Two PVC pipes at the outlet works were flowing clear water at a rate of approximately 30-gpm each. Pipes provide drainage for a toe drain/blanket located at the downstream toe of the dam. Did not observe seepage emanating from the toe or from areas downstream of the toe.

095 PVC outfall pipe for the toe drain. Pipe is located at the outlet works. Flowrate is approximately 15 gpm.

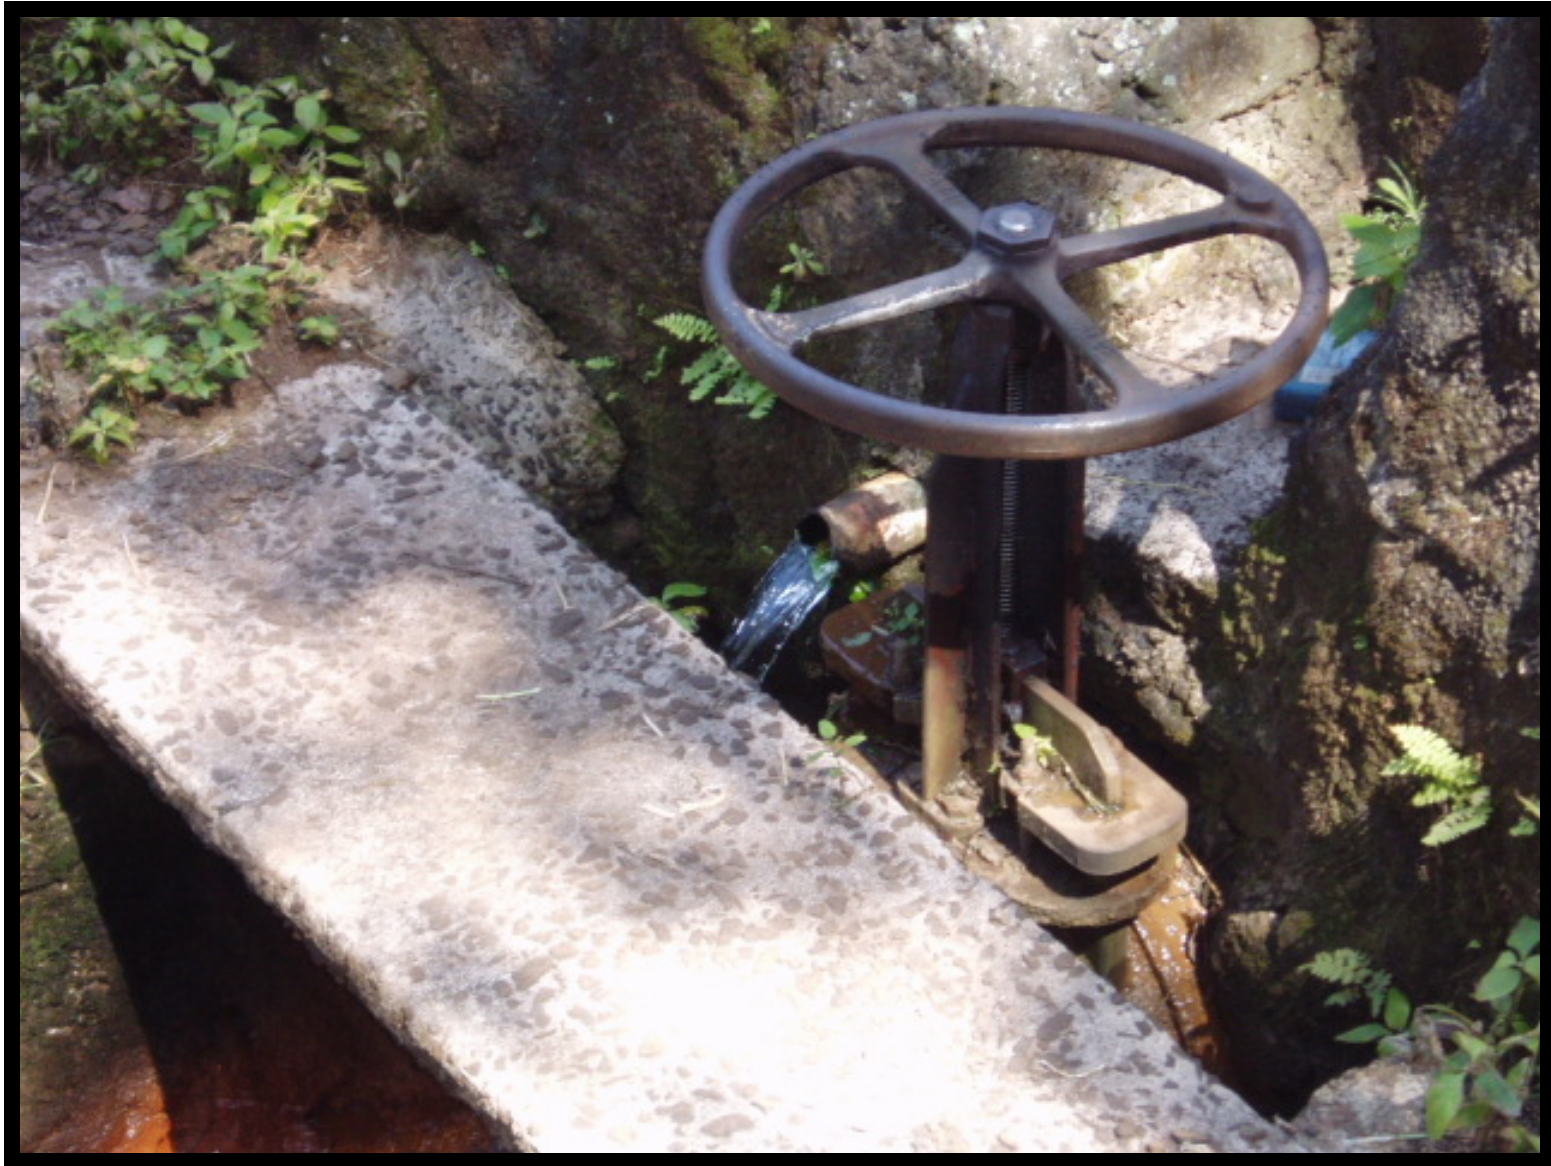
095 PVC outfall pipe for the toe drain (located behind the gate valve). Flowrate is approximately 15 gpm.

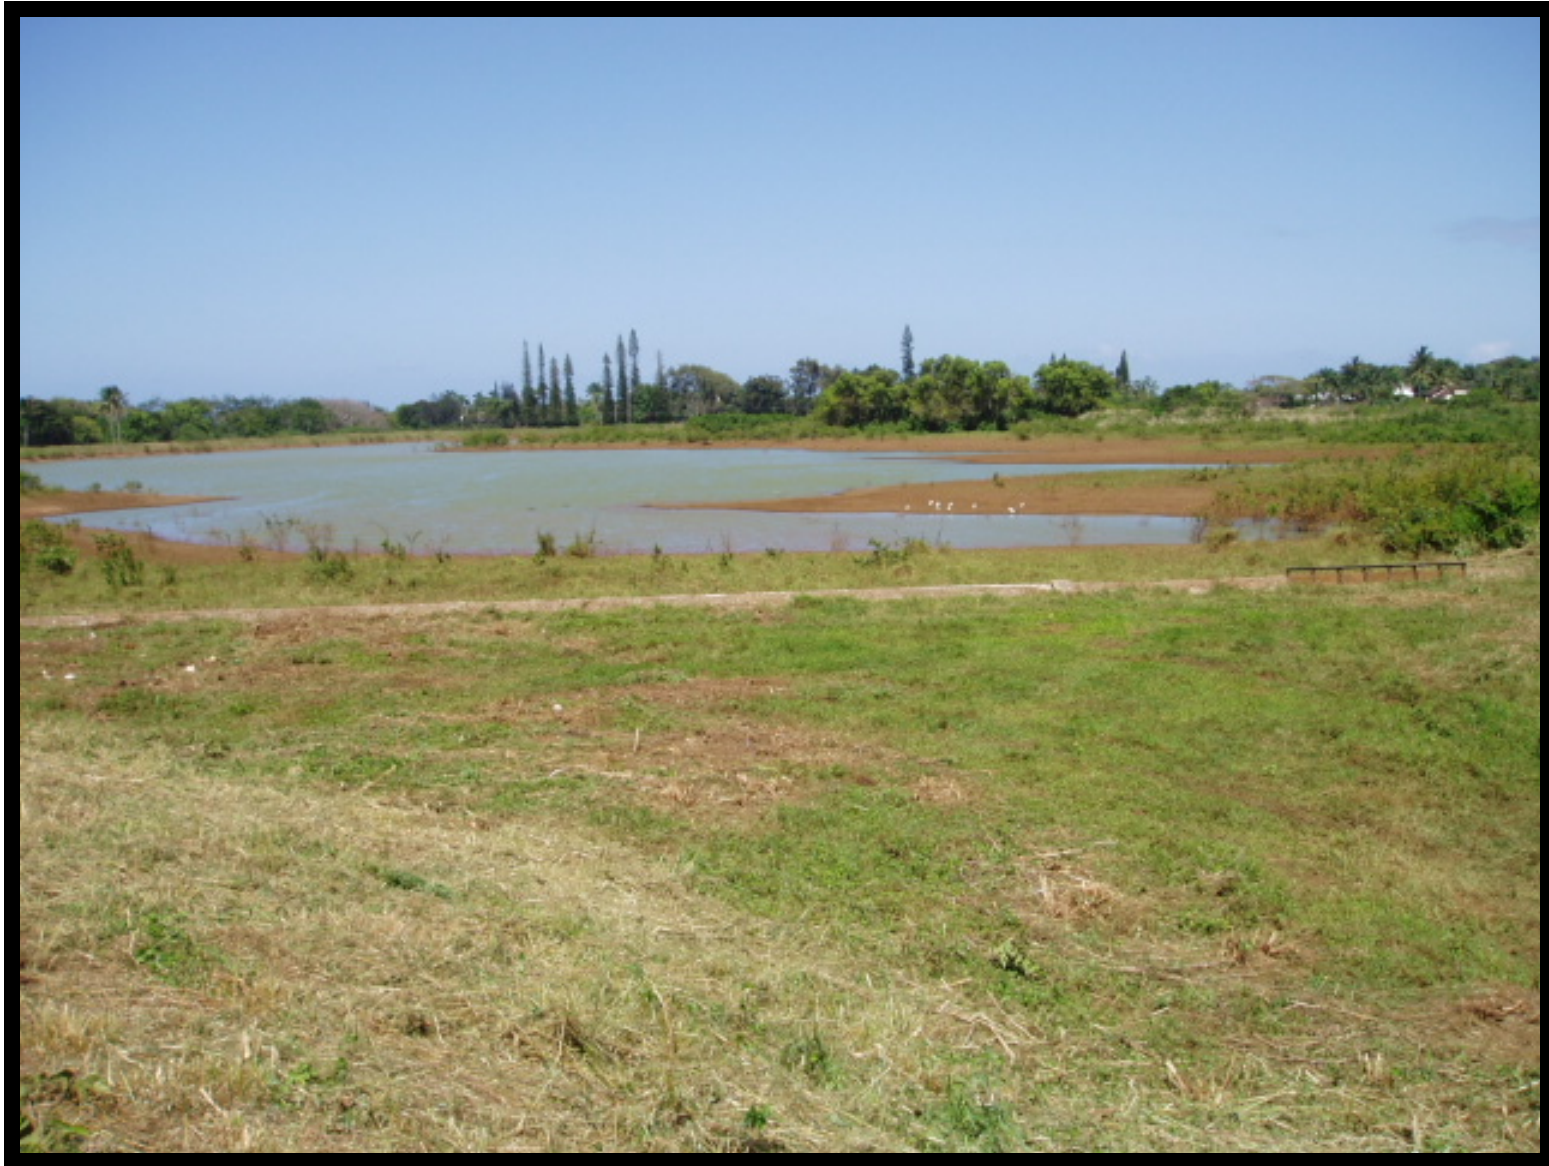
- a. The Spillway appeared to be in satisfactory condition, no corrective actions are required at this time.

095 spillway - The upstream slope of the dam is in the left background.

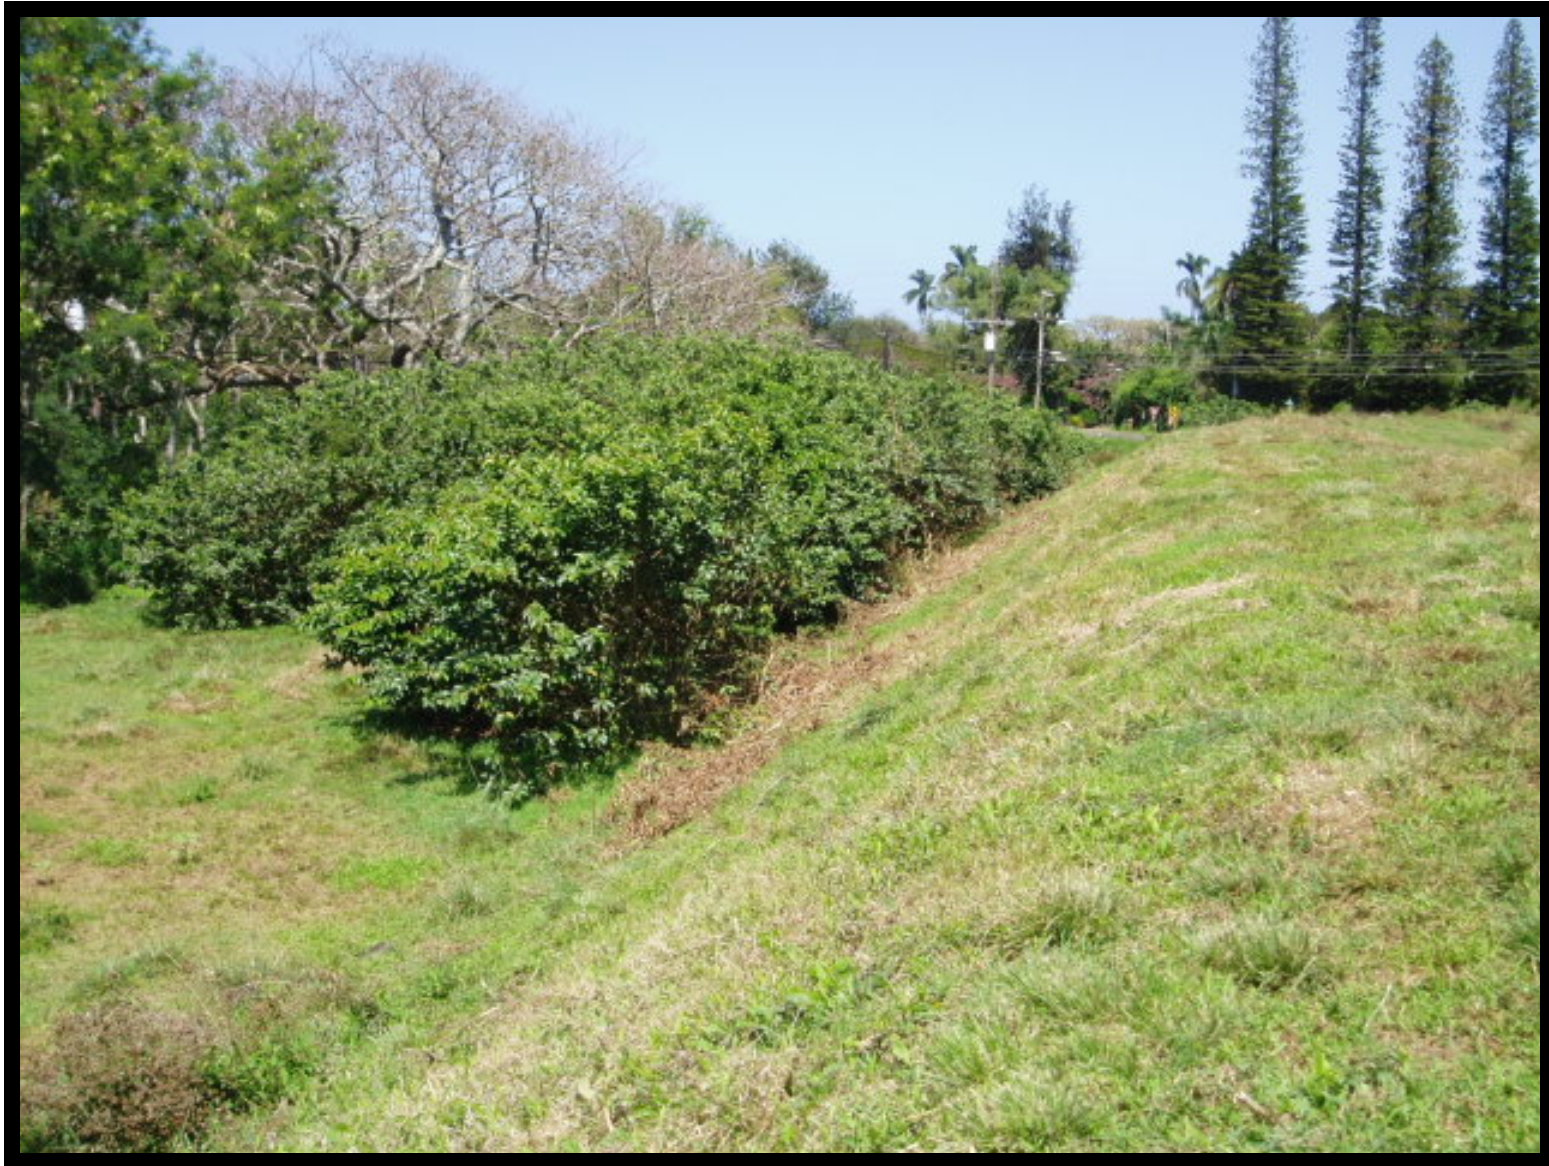
There is brush at the downstream toe on the right half of the dam. The downstream toe on the left half consists of short grass.

095 Brush along the downstream toe on the right half of the dam.
The brush should be removed.

- a. The abutments/toe appeared to be in fair to poor condition and requires corrective action.
- b. The abutment/toe area was not visible due to high grass and bush vegetation. Clear high vegetation and maintain low to enable easy visual inspection. Remove brush along toe on the right half of the dam.
- c. Routinely monitor and measure flow from the PVC drain blanket pipes at the outlet works.

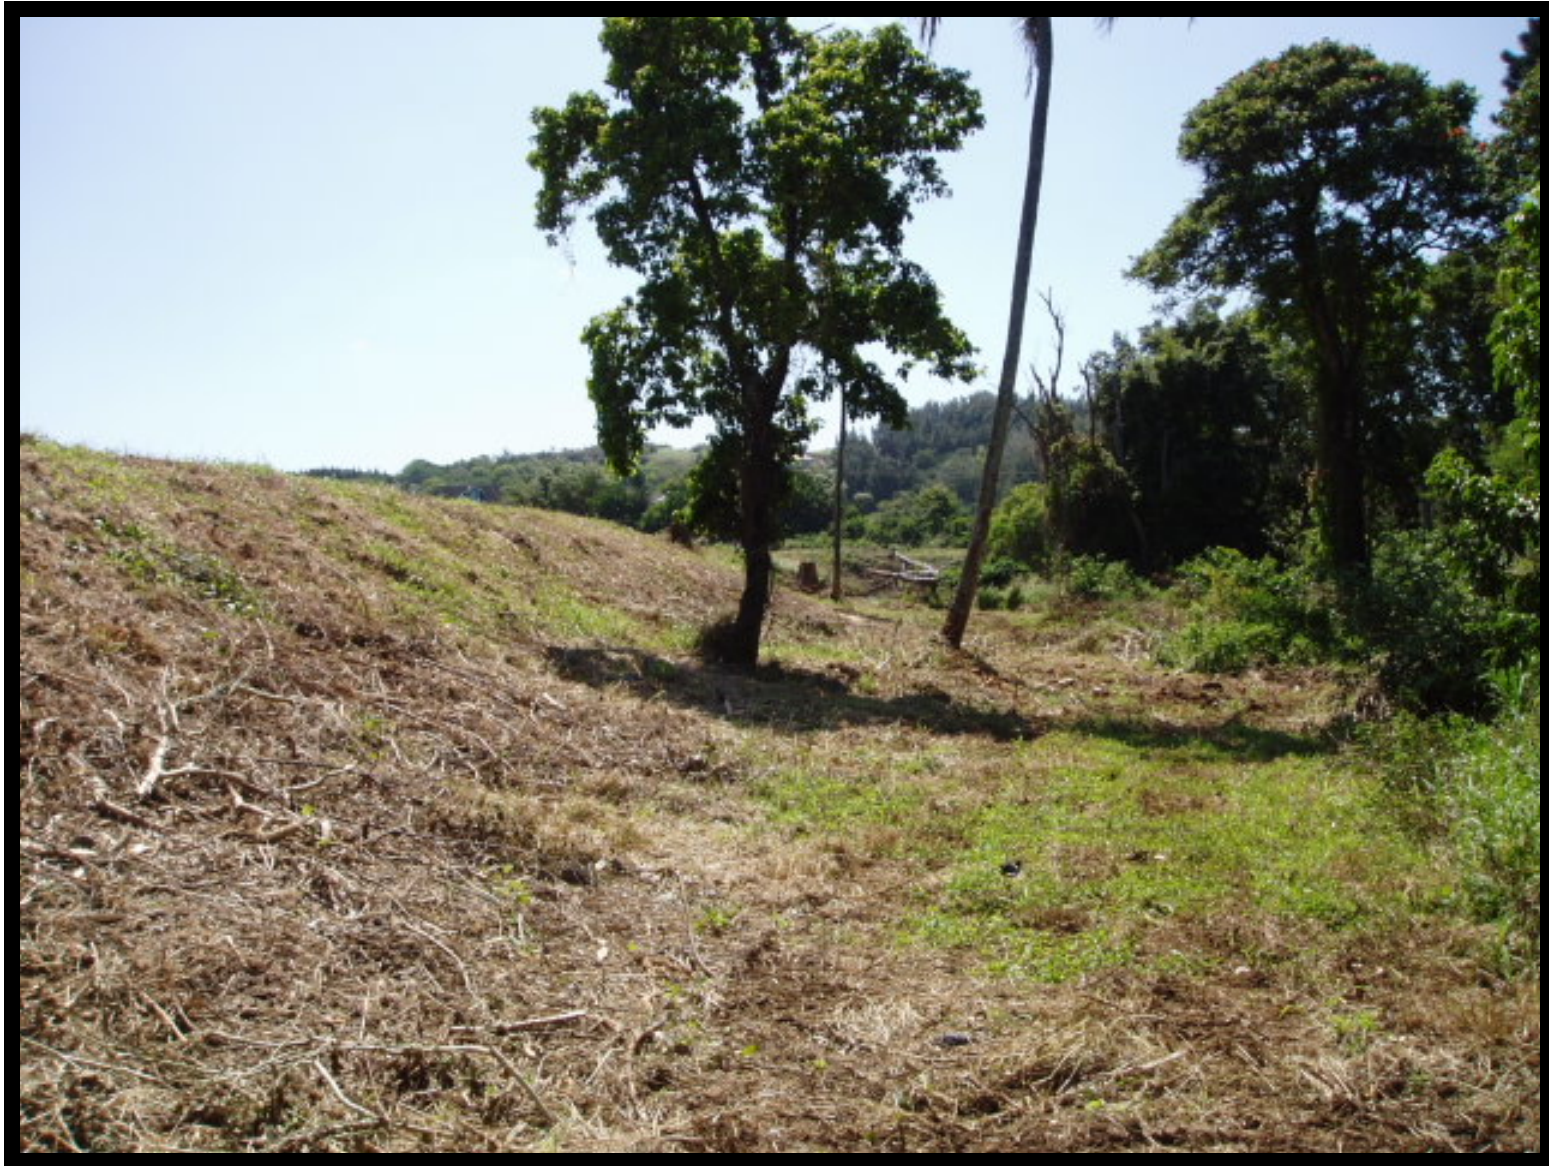
095 Downstream toe of the dam. Vegetation management is good. Grass covering the slope and toe area is short. The tree at the toe should be removed.

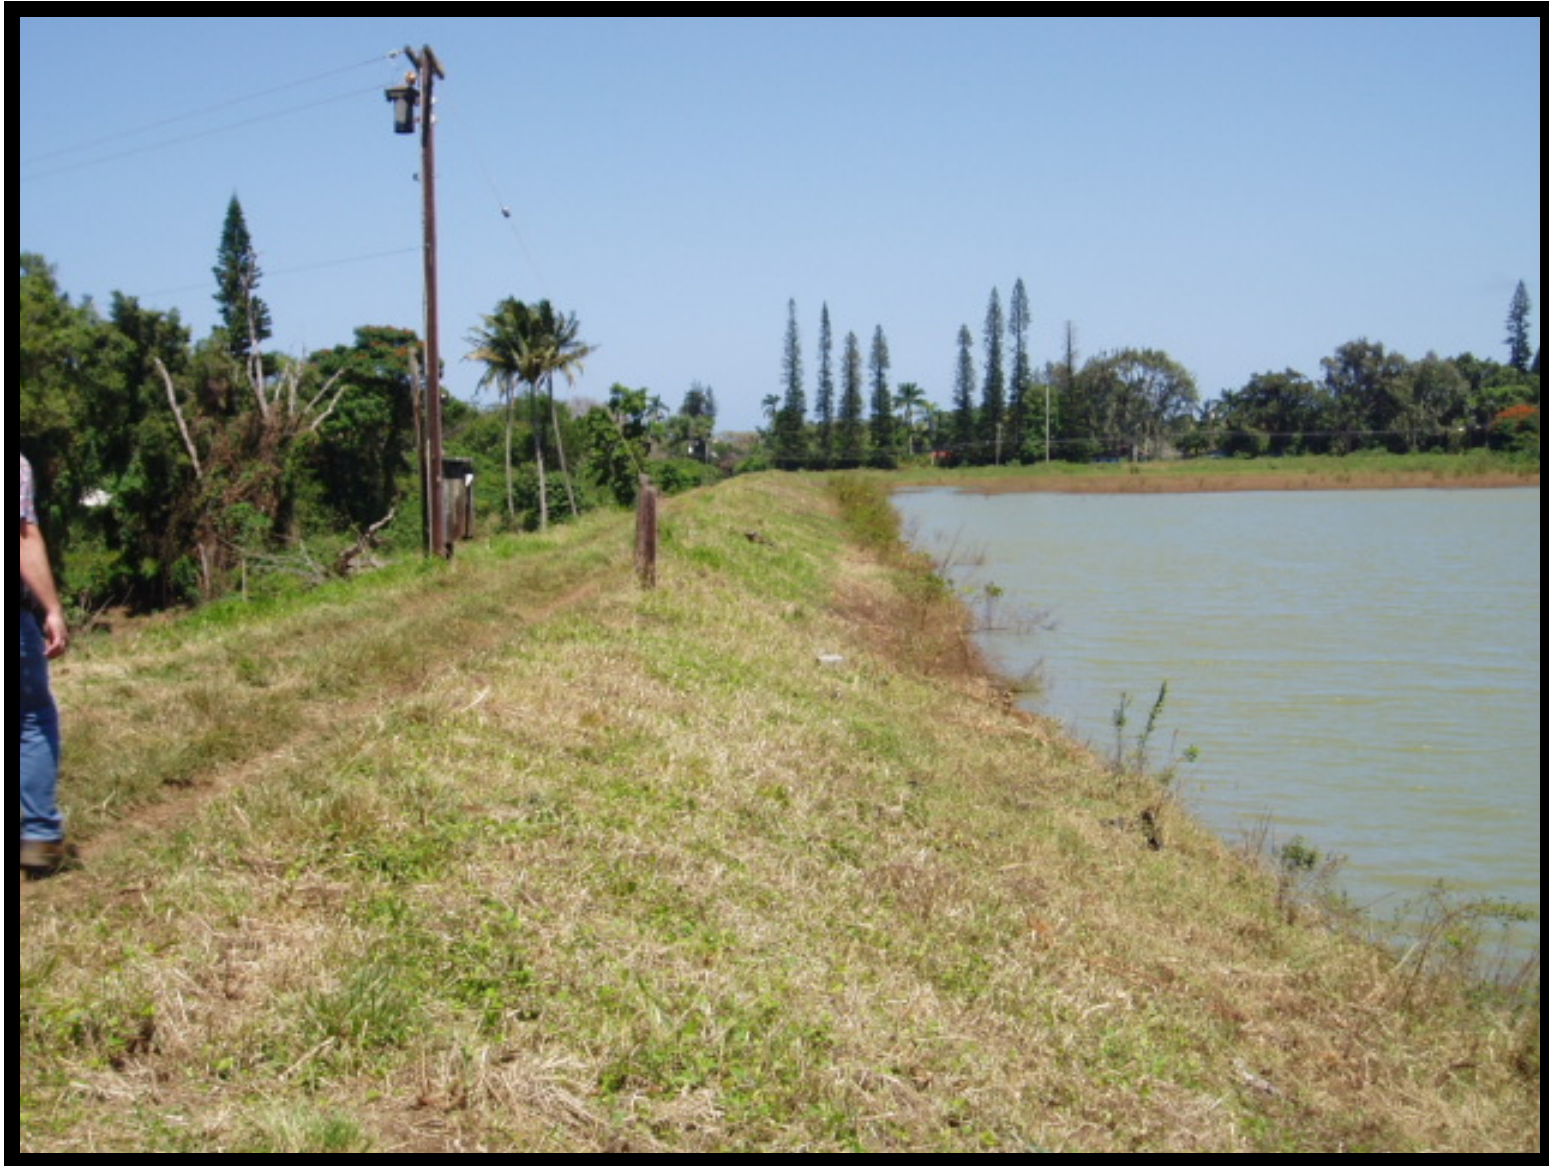
- a. The upstream slope appeared to be in satisfactory condition, no corrective actions are required at this time.

095 Upstream slope. Vegetation management is excellent. Short grass covers the slope.
